How to choose the right repair approach by using proper condition assessments.

By John M. Porter, PE, and Nathan D. Boutin, PE

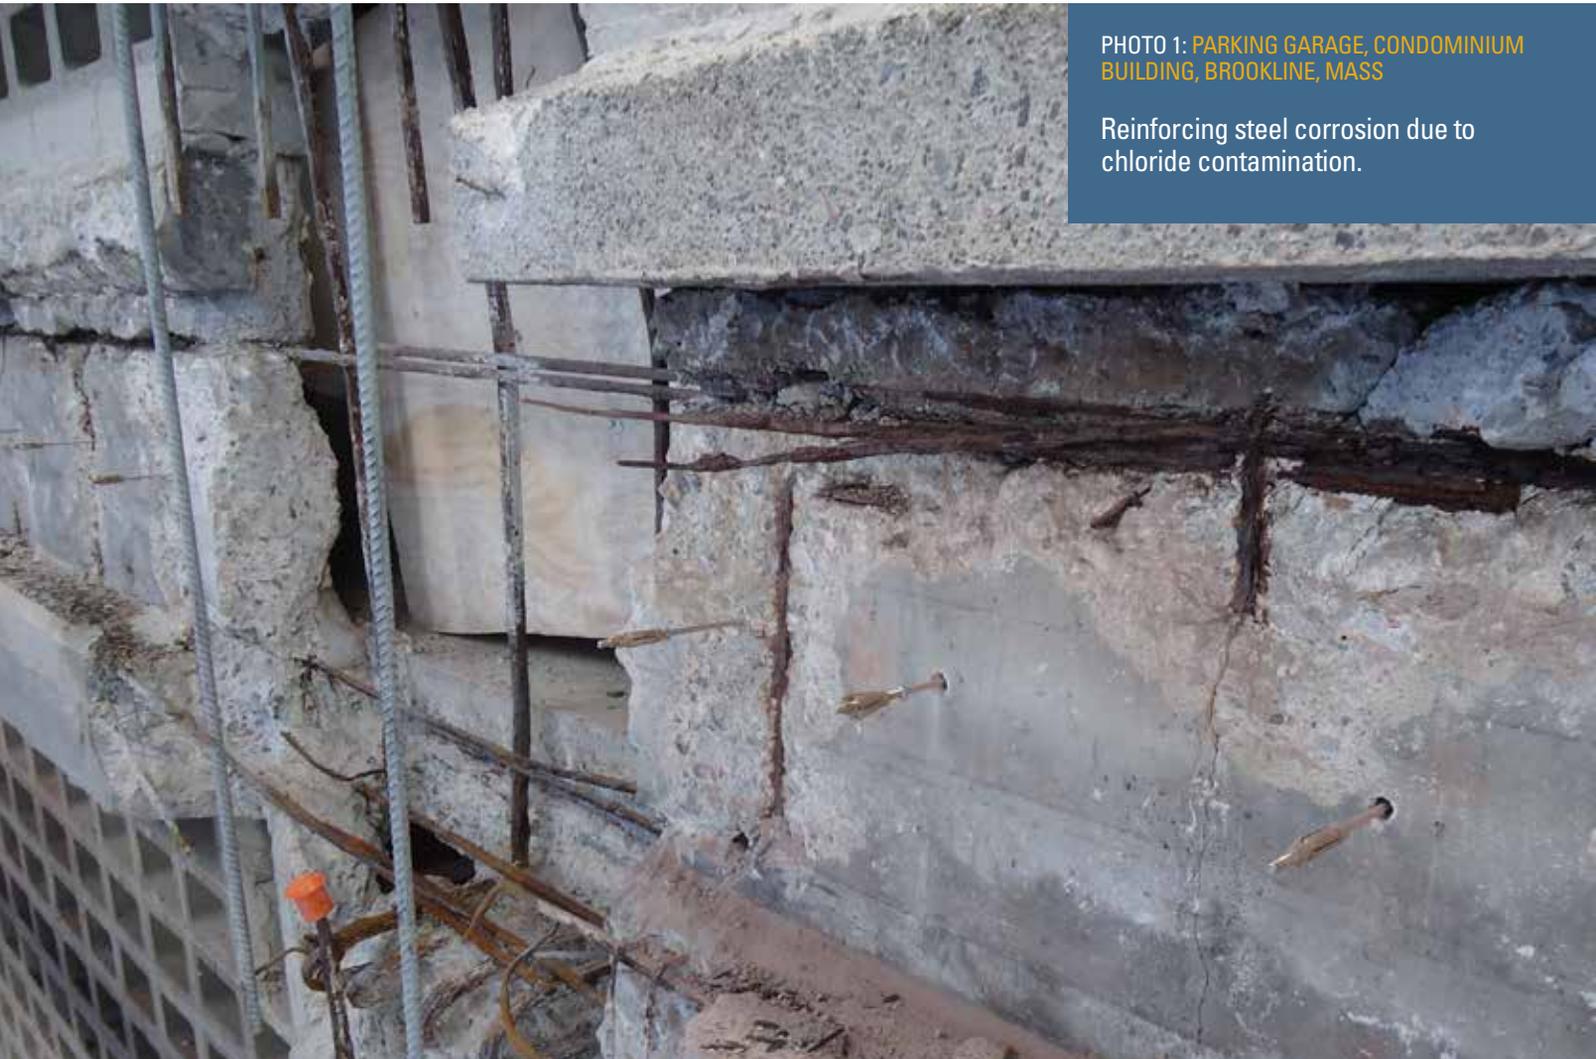
PHOTO 1: PARKING GARAGE, CONDOMINIUM BUILDING, BROOKLINE, MASS

Reinforcing steel corrosion due to chloride contamination.

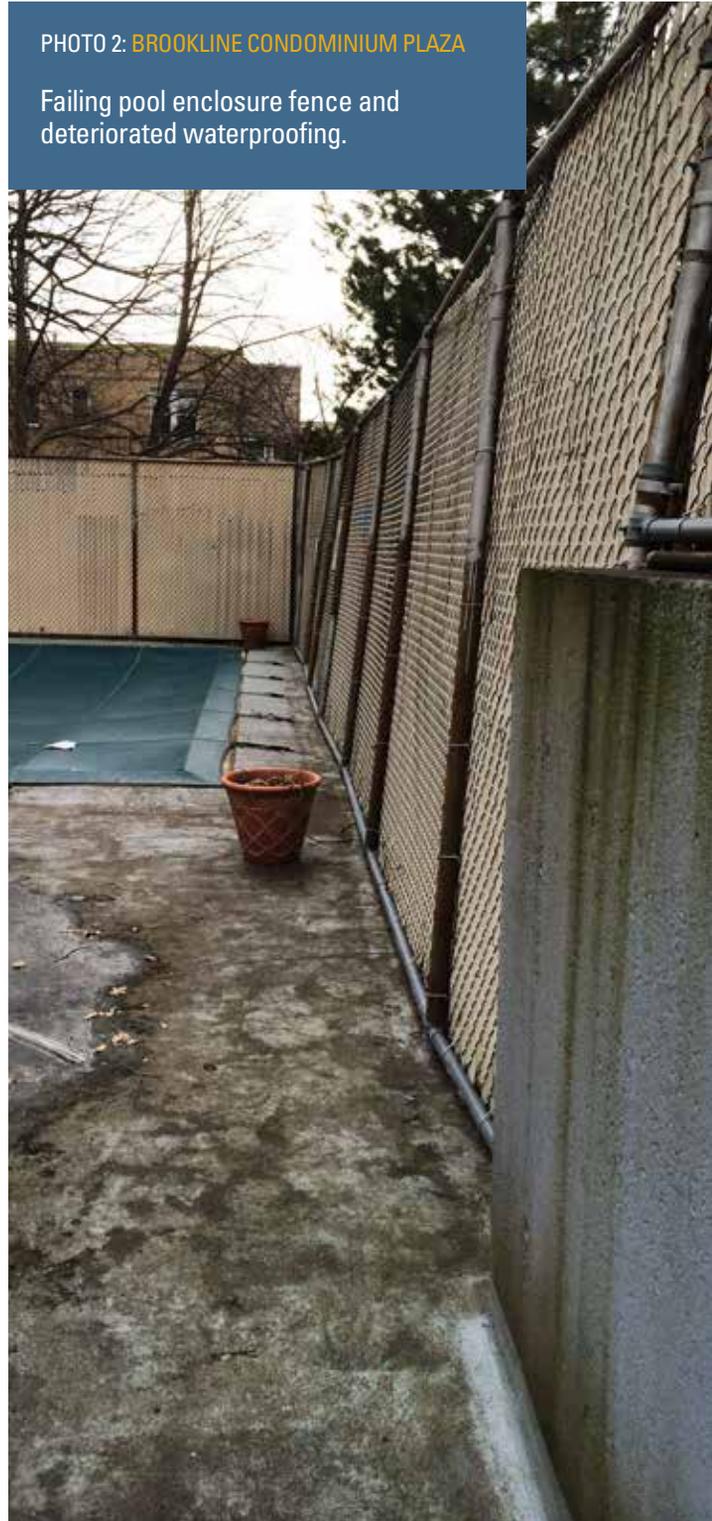
PHOTO 2: BROOKLINE CONDOMINIUM PLAZA

Failing pool enclosure fence and deteriorated waterproofing.

an engineer to perform the assessment, which revealed widespread and severe deterioration of the parking deck, failed plaza waterproofing, collapsing pool fencing (Photo 2), failed security doors, and deteriorated fire protection systems. Three rehabilitation alternatives were developed as part of the condition assessment that provided the board with the anticipated costs, advantages, and disadvantages of each alternative. The alternatives were designed to provide the owner with a range of initial construction costs and associated future maintenance and repair costs.

The board determined that repairing all current deterioration throughout the garage and plaza, as well as installation of pedestrian and vehicular-traffic-bearing membranes on the parking deck and plaza; new pool security fencing; and upgrades to entrance ramps, handrails, doors, security systems, and fire protection was the preferred rehabilitation approach. This was the most expensive of the three options presented and carried a heavy price tag (nearly \$500,000) for a small condominium building.

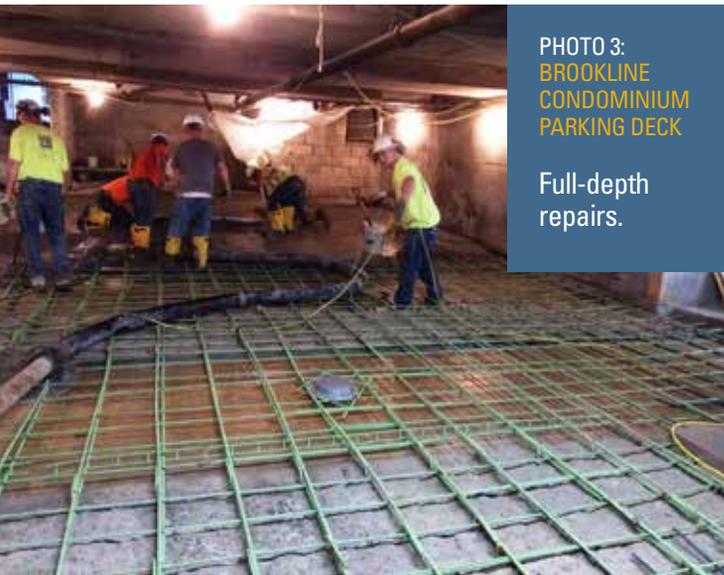
PHOTO 3:
BROOKLINE
CONDOMINIUM
PARKING DECK

Full-depth
repairs.

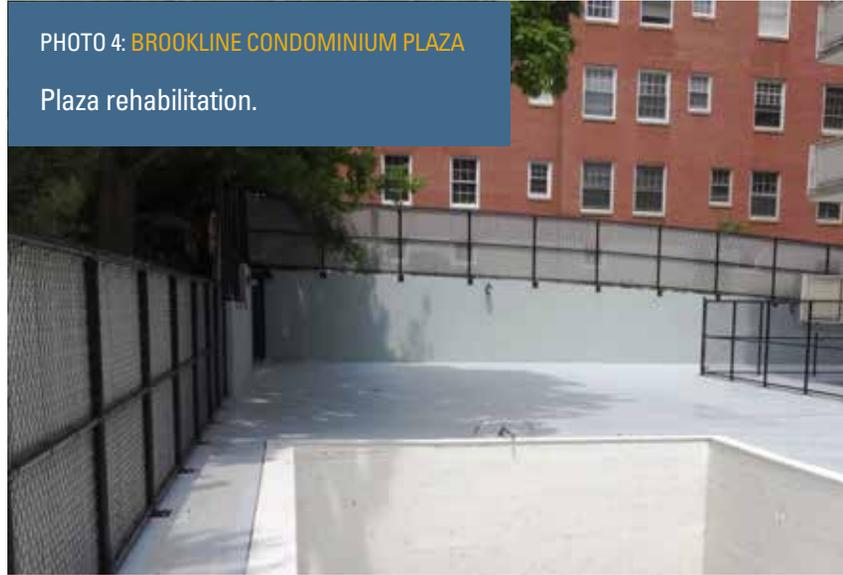
PHOTO 4: BROOKLINE CONDOMINIUM PLAZA

Plaza rehabilitation.

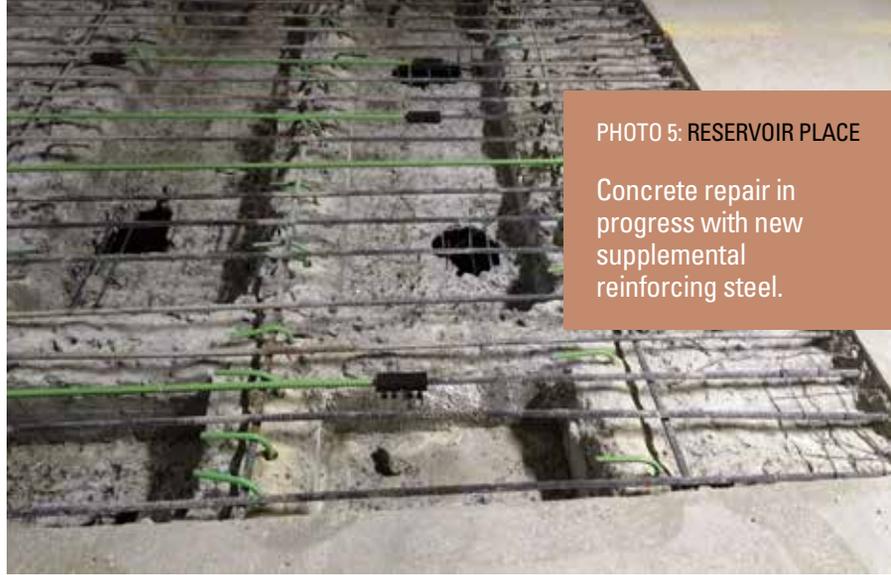
PHOTO 5: RESERVOIR PLACE

the garage. Nearly all concrete repairs required extensive temporary shoring to safely support the structure during demolition activities (Photos 5 and 6). The project involved seven phases that were subdivided further by the contractor based on the amount of shoring materials that could be installed in any given phase. To minimize the disruption to building occupants during the work because of sound vibrations, project documents required hydrodemolition to remove unsound concrete. When the contractor needed to use pneumatic demolition equipment for certain structural elements, the work was performed in off hours (nights and weekends). Monitoring during pneumatic demolition was also critical due to a laser eye surgery center that houses sensitive equipment directly above the construction zone. The engineer installed seismographs to monitor background ambient vibrations, trial demolition, and production demolition to verify that vibration levels did not exceed the laser-eye equipment threshold.

Concrete repair in progress with new supplemental reinforcing steel.

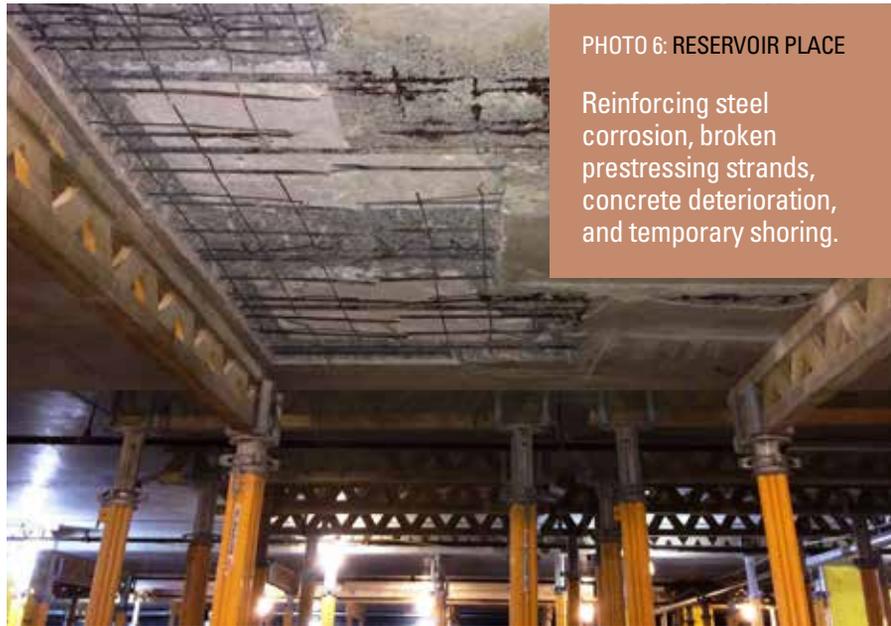
PHOTO 6: RESERVOIR PLACE

Reinforcing steel corrosion, broken prestressing strands, concrete deterioration, and temporary shoring.

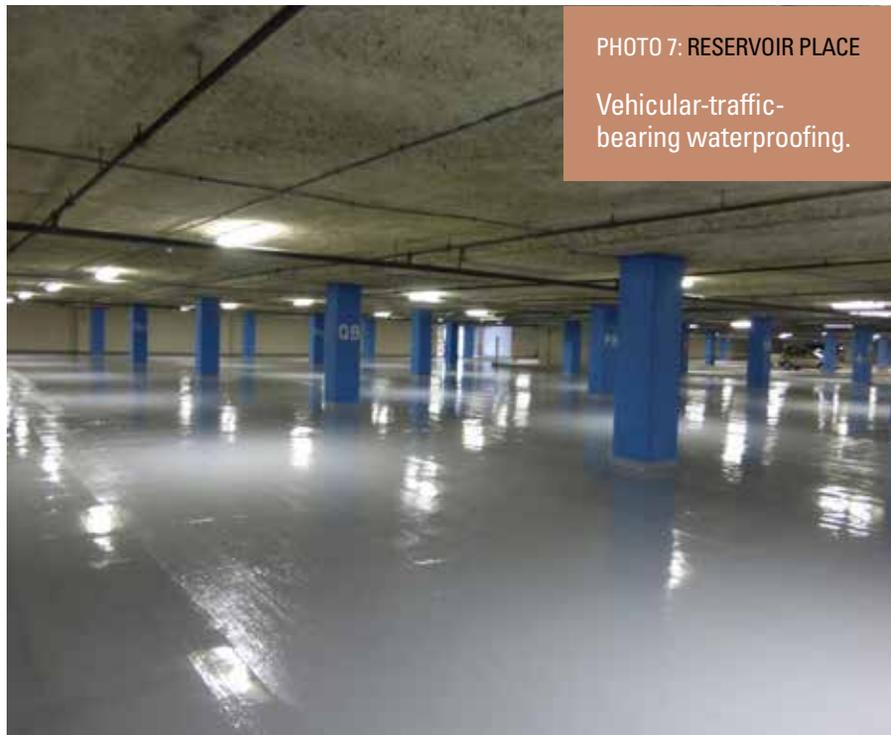
PHOTO 7: RESERVOIR PLACE

With the installation of more than 140,000 square feet of vehicular-traffic-bearing waterproofing (Photo 7), odors needed to be considered to reduce disturbance to garage users and tenants in the office space above. The engineer specified a low-odor system to reduce the impact on the building occupants. The project team also coordinated mechanical system functions with the building engineer to verify that elevator shafts and stair towers were put under positive air pressure during waterproofing installation and all doors and penetrations were sealed. Exhaust systems in the garage and temporary exhaust fans were also used to mitigate odors.

Vehicular-traffic-bearing waterproofing.

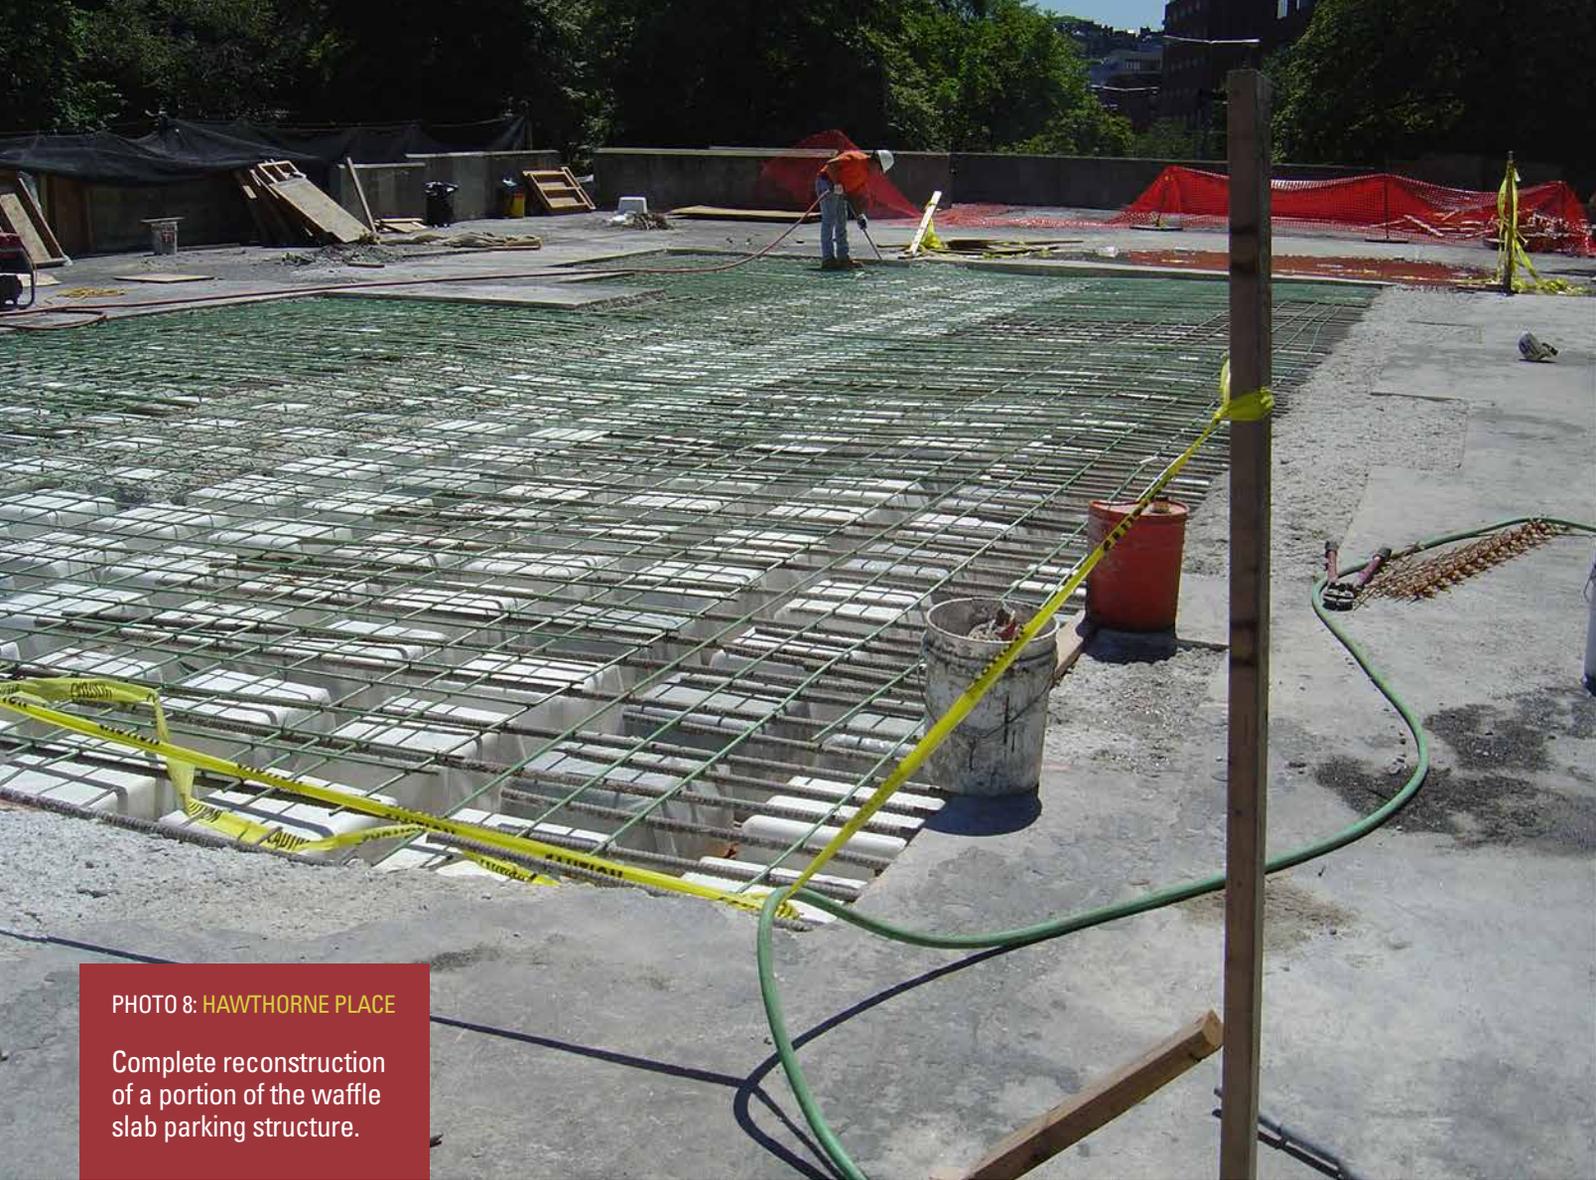
PHOTO 8: HAWTHORNE PLACE

Complete reconstruction of a portion of the waffle slab parking structure.

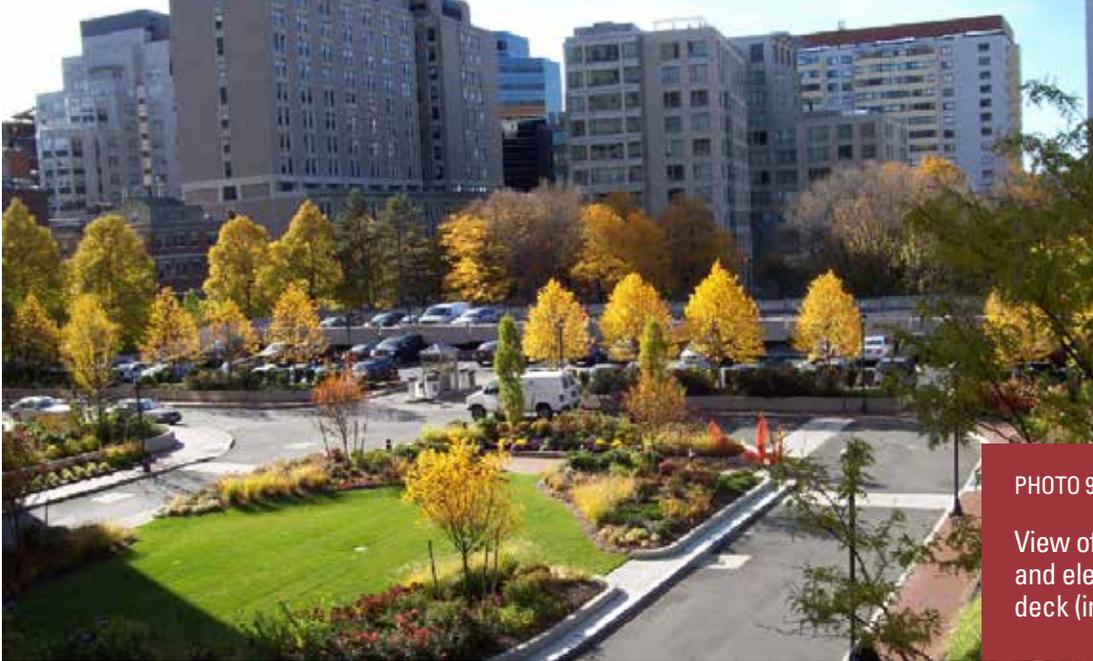
PHOTO 9: HAWTHORNE PLACE

View of the plaza level and elevated parking deck (in background).

maintain parking, and maintain egress and access to and from the condominium buildings. The final project provided the owner with a rehabilitated garage and plaza with the showcase of the project being the landscaping and hardscape features (Photos 9 and 10). These features included mature landscaping, new planters, lighting upgrades, roadways, and accessible walkways throughout the site for building occupants and garage users.

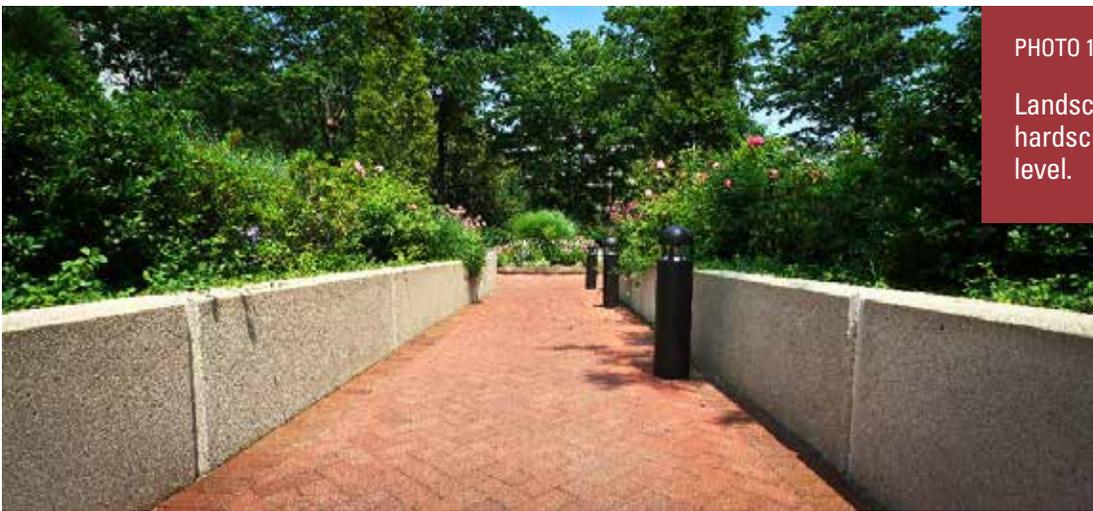
PHOTO 10: HAWTHORNE PLACE

Landscaping and hardscape on the plaza level.
