How to choose the right repair approach by using proper condition assessments.

By John M. Porter, PE, and Nathan D. Boutin, PE

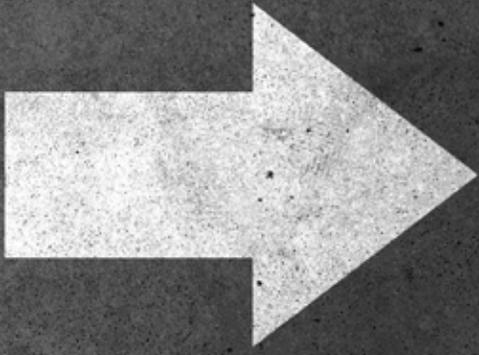
PHOTO 1: PARKING GARAGE, CONDOMINIUM BUILDING, BROOKLINE, MASS

Reinforcing steel corrosion due to chloride contamination.

This two-level, partially-below-grade concrete parking structure built in 1964 is located below a seven-story condominium building and accommodates about 30 vehicles. This small garage is critical to the condominium owners as other parking options in this congested area are limited. A plaza above the garage is used as a common space for owners to utilize the swimming pool that is recessed into the elevated plaza level structure. Exposure to de-icing salts and moisture eventually led to chloride contamination of the concrete and widespread deterioration.

In the spring of 2013, a contractor was hired directly by the condominium association to repair the most severely deteriorated area of the elevated concrete parking deck. Due to the severity of deterioration, the entire slab was demolished within the repair zone, which came as a surprise to the condominium owners and the contractor. At that point, the contractor and the board of trustees stopped the project and quickly retained a structural engineer to prepare construction documents for the slab replacement. The team worked together to develop a fast-track repair approach to reconstruct the parking deck, which was completed in approximately one month.
